Subject: Spring 2010 Wetland Inspection Keith Middle School, New Bedford,
Massachusetts

SITE PHOTOGRAPHS
May 2010 Wetland Inspection
Keith Middle School
New Bedford, Massachusetts

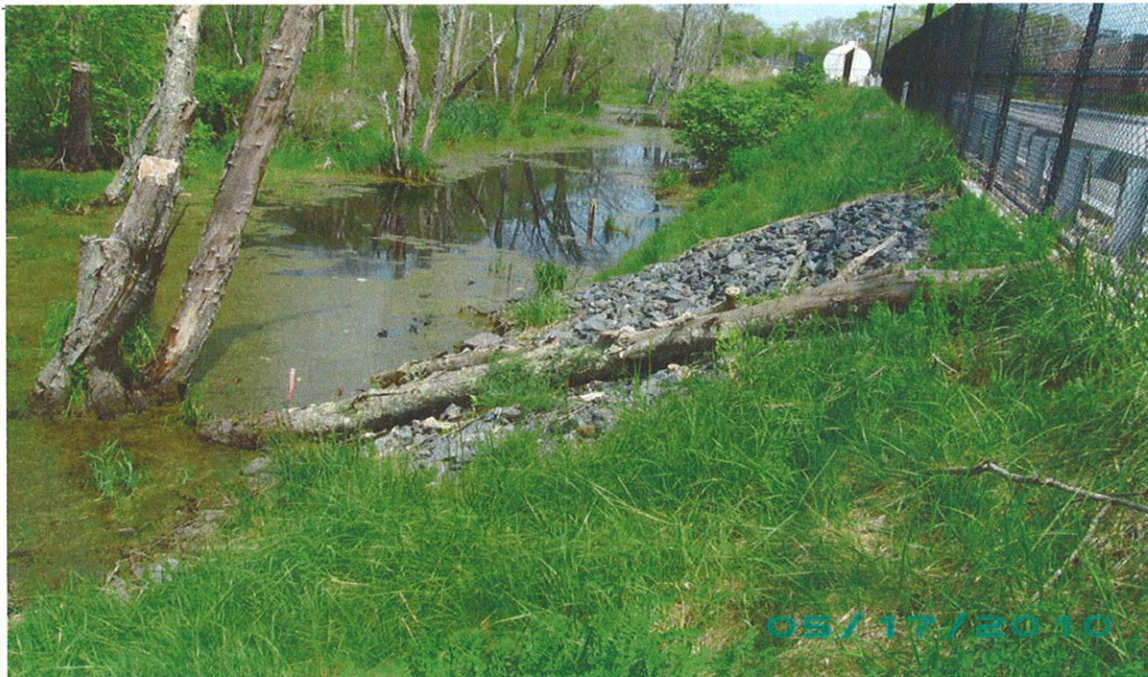
1) Slope in central portion of wetland/cap edge looking north.

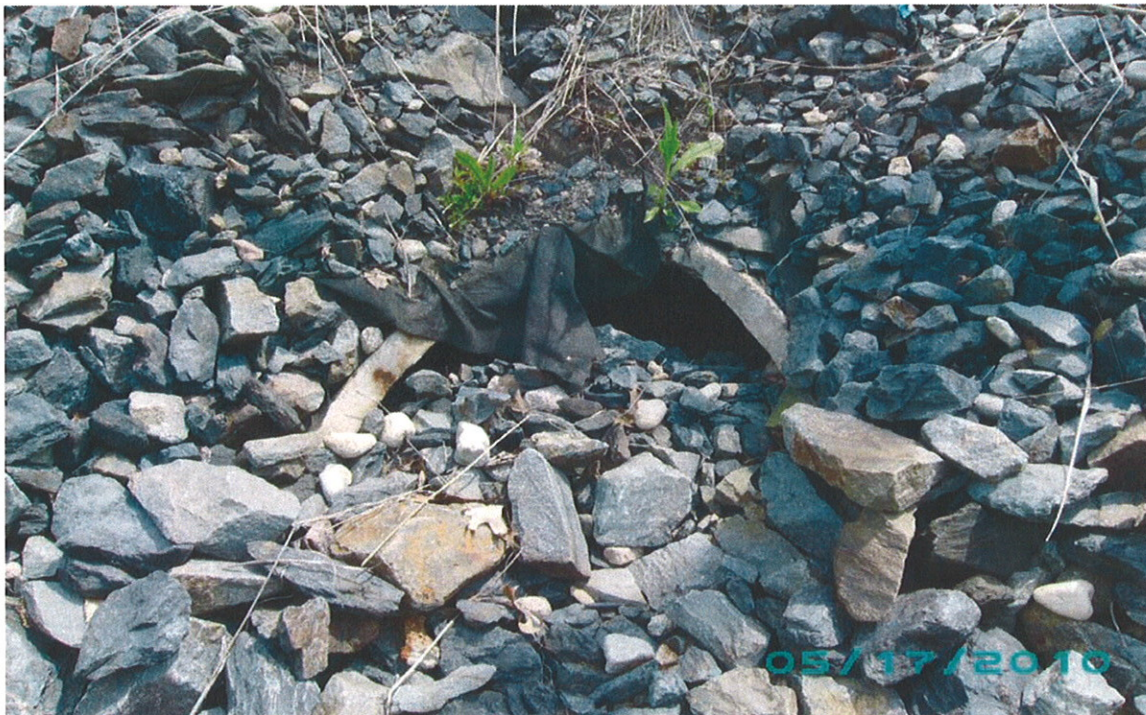
2) Partially blocked culvert outlet near central portion of wetland/cap edge.

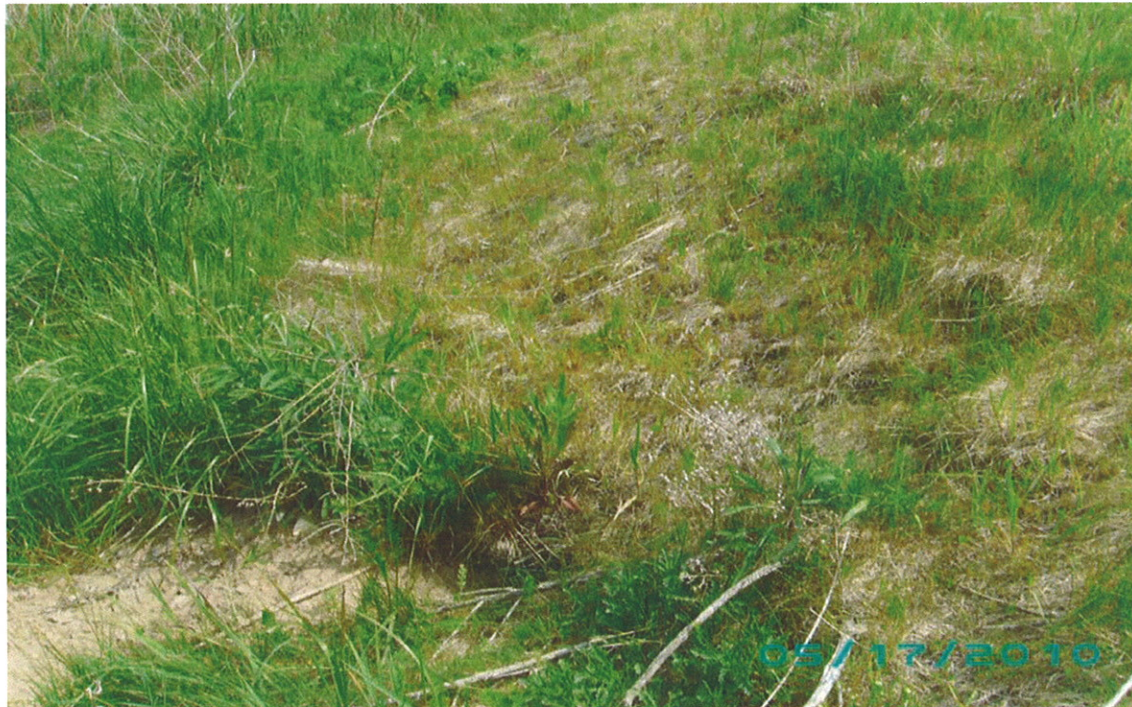
In general, the slope extending down to the wetland from the parking lots and rear school access drive is well vegetated with grasses and herbaceous plants. One small area of thin vegetative cover remains within the northwestern portion of the slope. The thin cover revealed the slope stabilization netting used during construction of the slopes. However, this area appears to be currently stabilized with no erosion evident with increased vegetation present since the 2009 site inspection. Overall, no evidence of erosion or sedimentation into the adjacent wetland was noted during the site inspection.

3) Area of thin vegetative cover in northwestern portion of cap slope. Note woodchuck burrow in lower central portion of photograph.

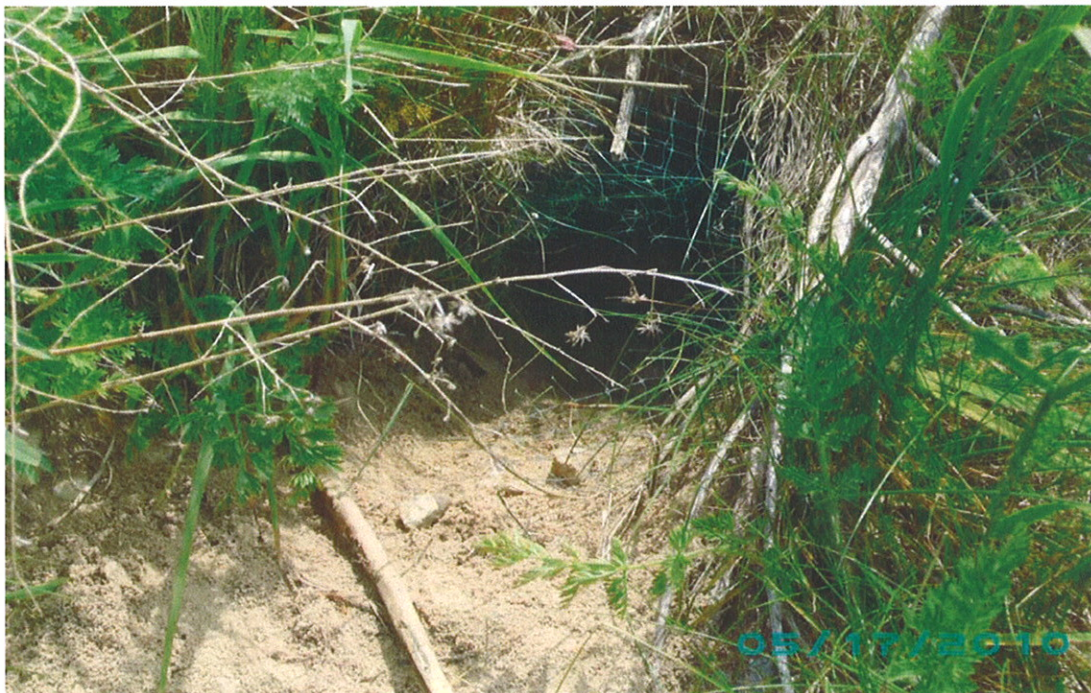
A woodchuck burrow is present within the northwestern portion of the wetland/cap slope edge. The resident(s) of this burrow should be trapped and removed and the burrow filled in to minimize further disruption to the cap integrity.

4) Woodchuck burrow along northwestern portion of slope. Note slope netting at top of burrow entrance.

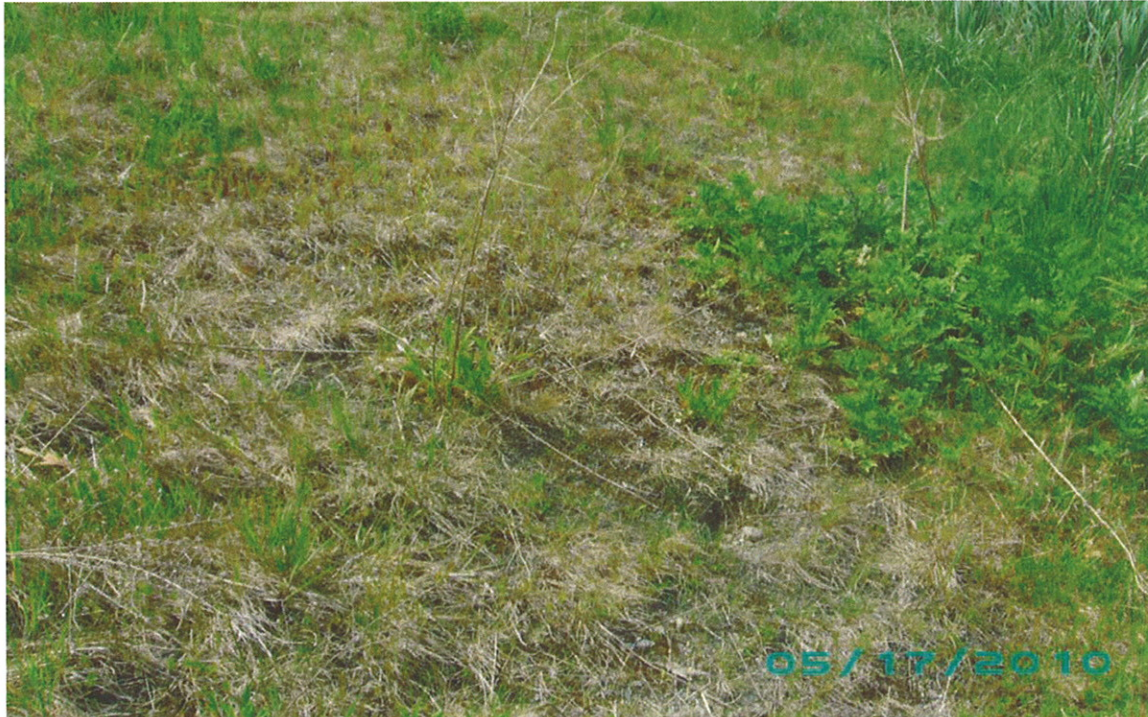
5) Area of thin vegetative cover in northwestern portion of wetland/cap slope.

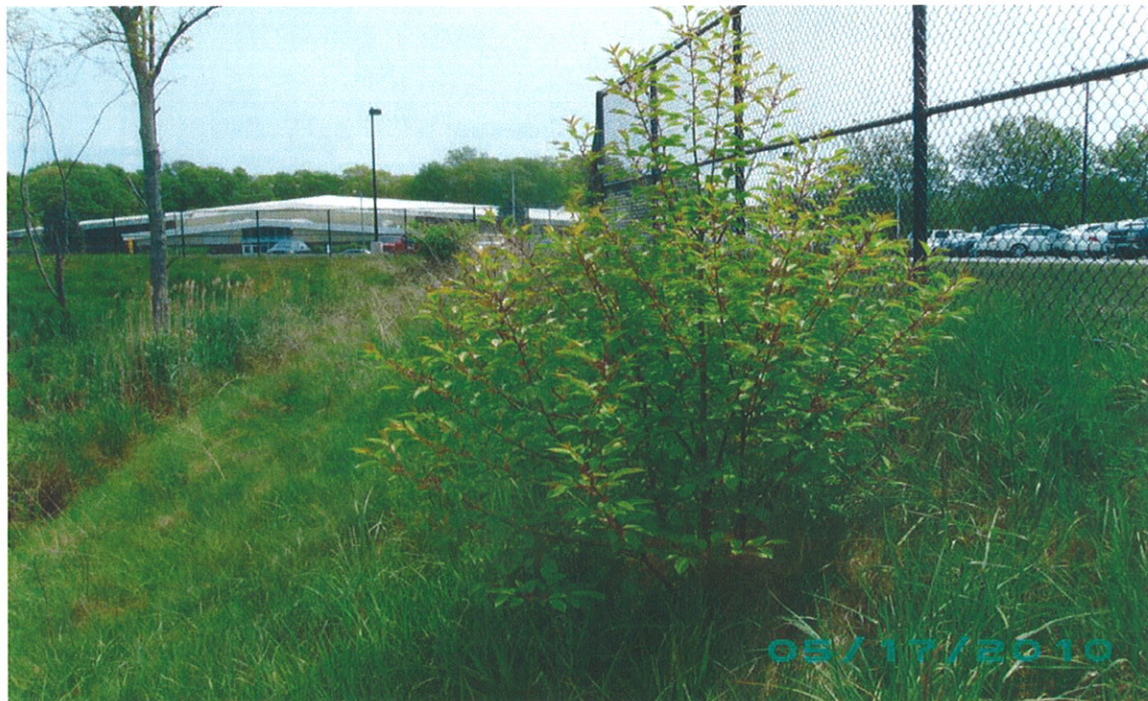
In addition, several small tree saplings are present on the cap slope. In order to prevent the roots of these trees from penetrating further into the cap as well as to minimize the potential for additional slope failure should these trees be toppled by wind when they become larger, it is recommended that these saplings be cut periodically (once a year). A few stands of the invasive plant Japanese knotweed (*Polygonum japonica*) are also present in the vicinity of stormwater outfalls and in the southern portion of the wetland/ cap slope. These plants form a dense overstory that precludes understory vegetation from becoming established due to the heavy shading. Erosion is more likely to occur beneath the Japanese knotweed stands due to the absence of the ground vegetation. It is recommended that the knotweed stands be periodically cut during the growing season (once a month) so that understory vegetation can become established.

6) Small cherry sapling along northern cap slope.

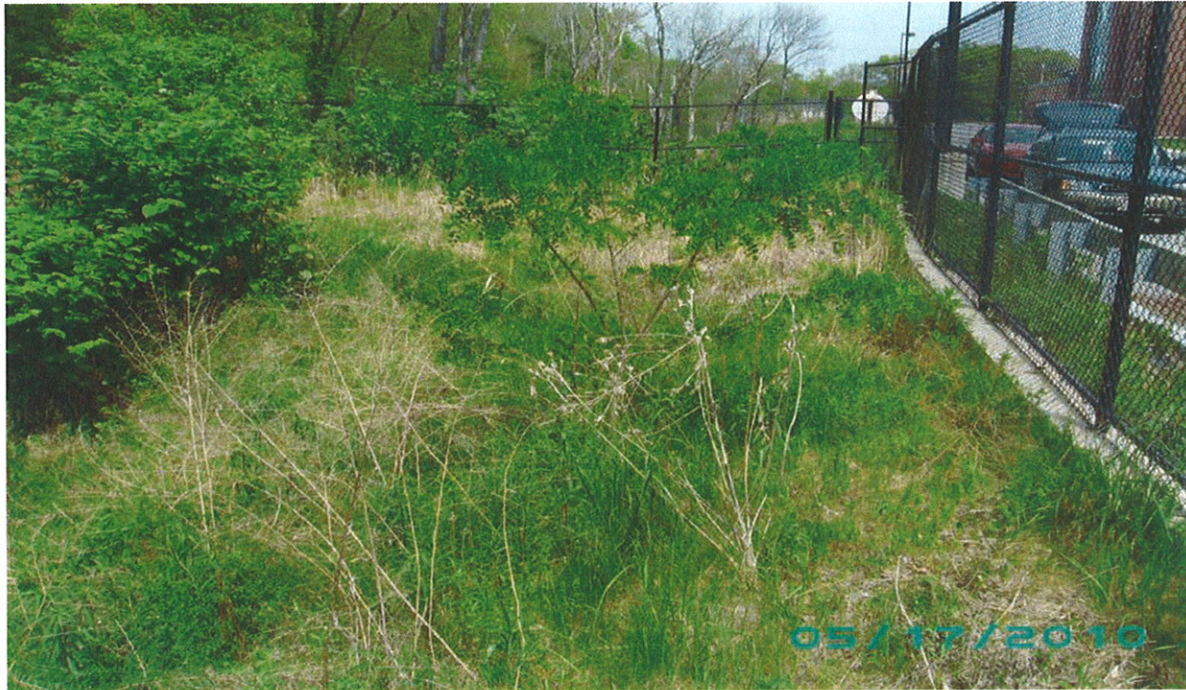
7) Southern portion of cap slope. Note small locust sapling in center of photo.

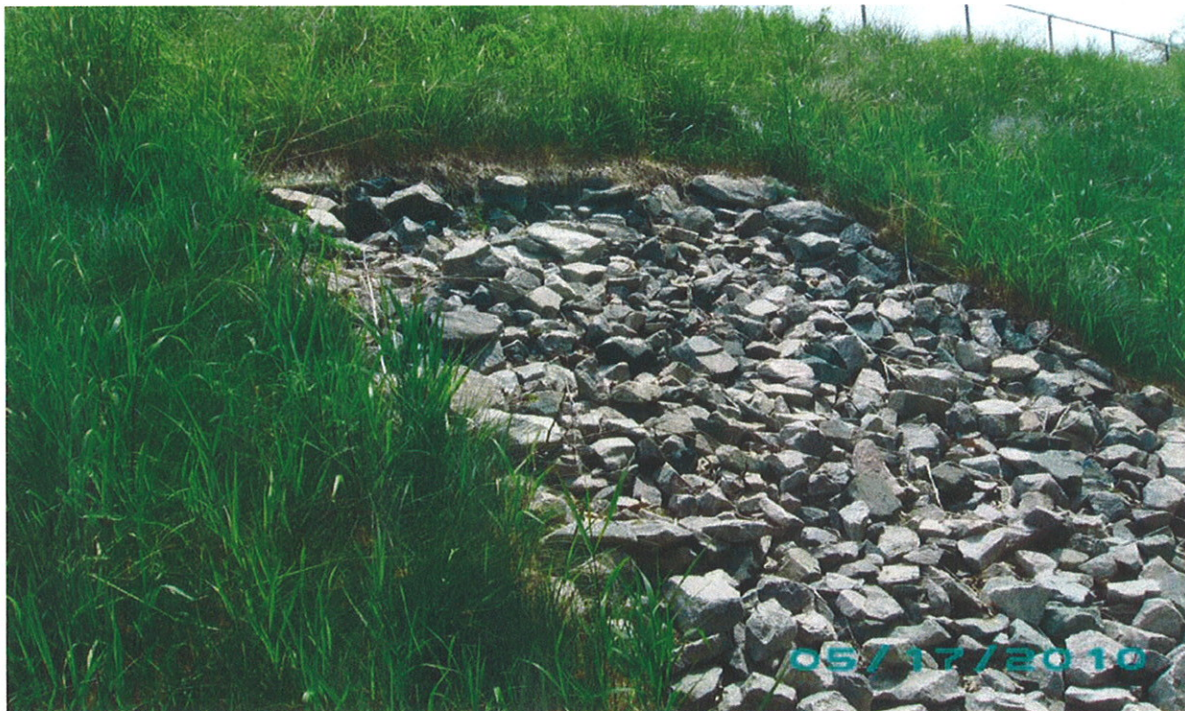
The area of slope failure previously noted during the 2008 inspection has been stabilized with riprap and appears to be stable. The silt fence previously installed downgradient of the repaired area should be removed.

8) Previously repaired portion of cap slope.

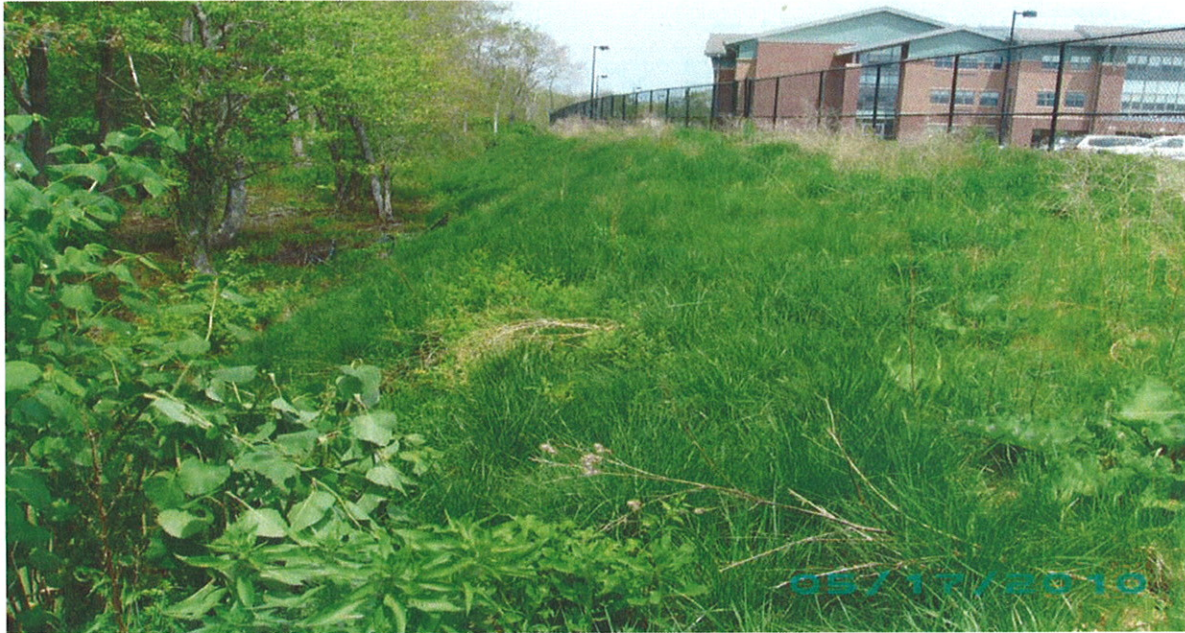
9) Southern portion of wetland/cap slope. Vegetation is well established.

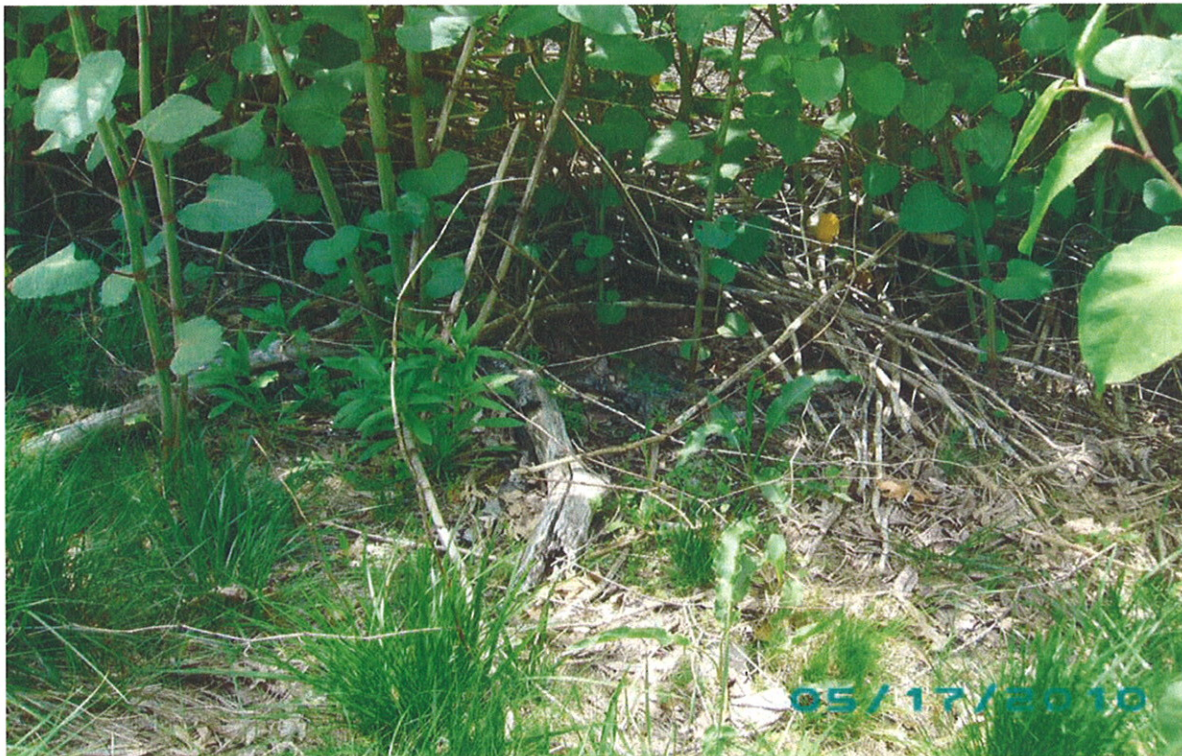
10) Stand of Japanese knotweed along southern portion of wetland/cap slope.
